## 2026 SANITARY MANHOLE RELINING PROGRAM

### Attachment 1 – Photos and Measurements of 2026 Relining Locations

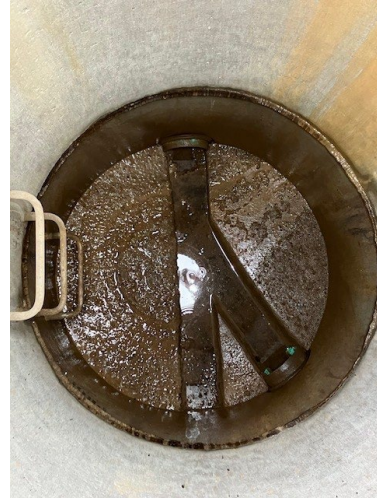
MH 480

438	52 Street east of 57 Avenue	Infiltration around base and weeping from barrel seams	Full barrel	1220	2.42	
480	5641 57 Avenue	Infiltration around base and weeping from barrel seams	Half barrel	1220	2.82	
483	57 Avenue and Sunrise Crescent	Medium infiltration	Full barrel	1220	3.73	
507	59 Avenue north of 58 Street	Infiltration around base and weeping from barrel seams	Full relining	1220	2.8	Infiltration in barrel/benching
574	63 Avenue and Douglas Place	Infiltration around base and weeping from barrel seams	Full relining	1220	3.58	
577	63 Avenue north of Winter Drive	Infiltration around base and weeping from barrel	Half barrel	1220	4.1	
627	55 Street west of 63 Avenue	Medium infiltration under lead, infiltration dripper from above	Half barrel	1220	3.2	
832	Erhart Close pathway	Heavy encrustation	Half barrel	1220	2.29	
924	5914 47 Avenue	Infiltration around base and weeping from barrel seams	Half barrel	1220	3.5

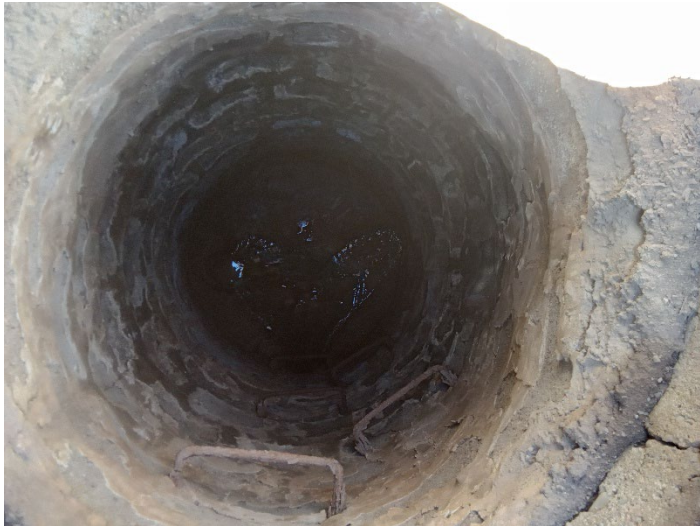
MH 230

230	49 Avenue and 51 Street	Infiltration around base and weeping from barrel seams	Half barrel	1220	2.92	
276	5114 46 ST, north side of property	Partial relining & benching repair	Half barrel	1220	2.51	Infiltration in barrel/benching
416	5521 46 Street (across from Tim Hortons)	Infiltration around base and weeping from barrel seams	Full barrel	1220	2.46

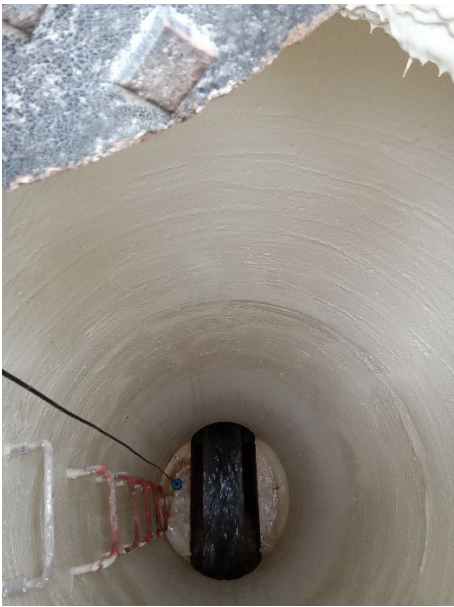
MH 85

<b>Manhole Relining</b>						
<b>Manhole #</b>	<b>Locations</b>	<b>Description of Work</b>	<b>Scope</b>	<b>Barrel Diameter</b>	<b>Depth (meters)</b>	<b>Notes</b>
85	West of Vistas storm pond	Medium infiltration and encrustation sounds seam of south pipe and barrel	Base and benching	1220	4.16	
90	Pathway south of 29 Vantage Crescent	Infiltration around base and weeping from barrel seams	Full barrel	1220	3.5	
92	Pathway behind 33 Viceroy Crescent	Infiltration around base and weeping from barrel seams	Full barrel	1220	2.5	
196	4826 49 Street	Infiltration around base and weeping from barrel seams	Half barrel	1220	3.09	
204	5703 48 Avenue	Infiltration around base and weeping from barrel seams	Full barrel	1220	2.6	
210	5210 48 Avenue (brick manhole)	Infiltration around base and weeping from barrel seams	Half barrel	1220	2.1	
216	Alley behind 4802 54 Street	Infiltration around base and weeping from barrel seams	Full barrel	1220	2.06
